# Repairing Leveler Support in a Hollow-Core Bifold Door

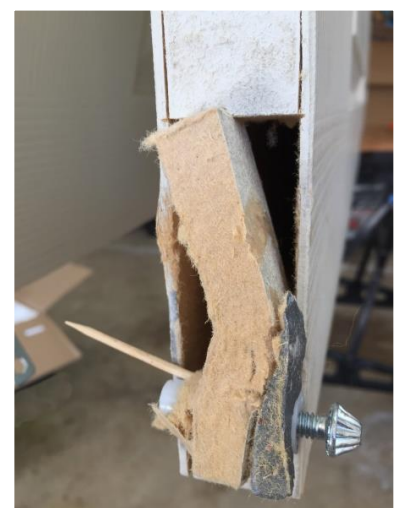
MDF strip displayed the consistency and stiffness of delaminated cardboard.

Marked the cut-line with the "decapitated" base moulding and used a multitool with 3/4" wide blade to remove the defective MDF strip. Slid a thin putty knife between the outside panel and the multitool cutting blade to prevent accidental damage to the panel.

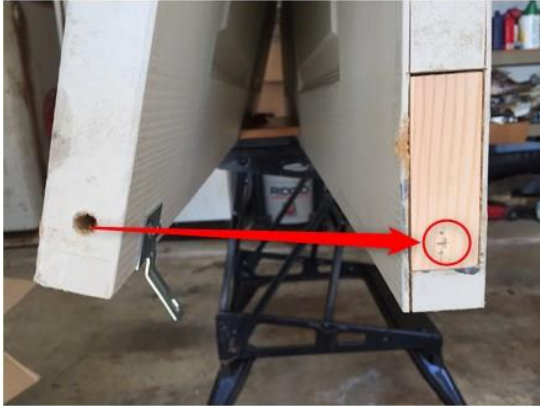
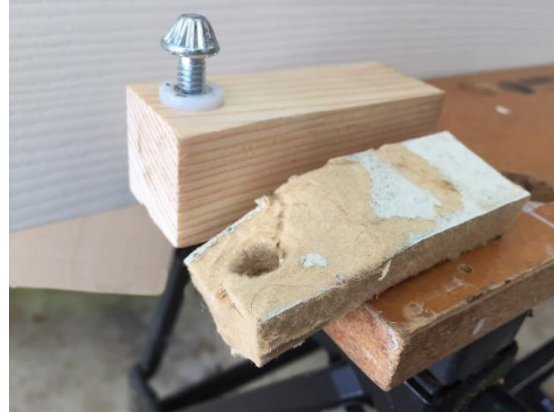
Notice the difference between old and new support structures. Thickness of the MDF strip was 15mm while the wooden block is almost twice as thick at 29mm.

Hole in bottom of opposite panel was used to transfer location of leveler hole to our block of wood.
