# Repairing Leveler Support in a Hollow-Core Bifold Door

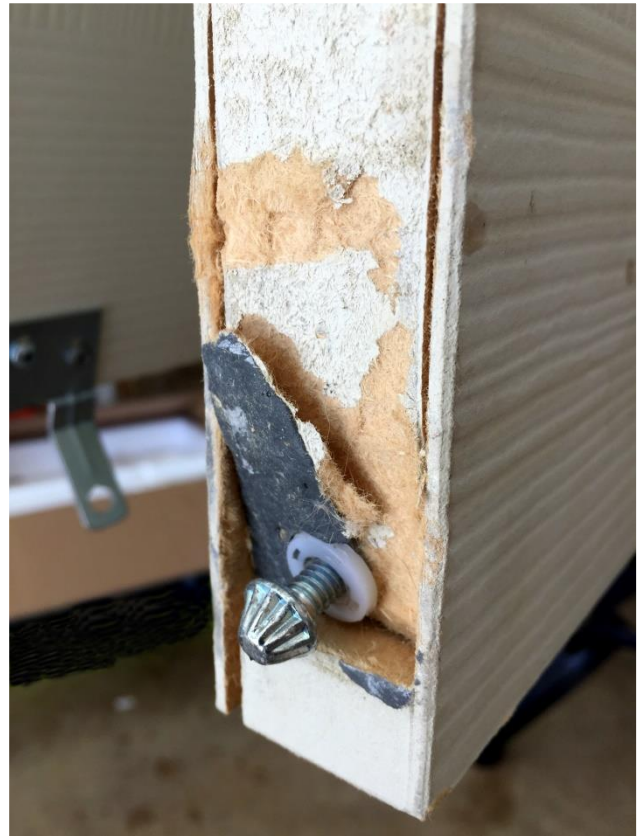
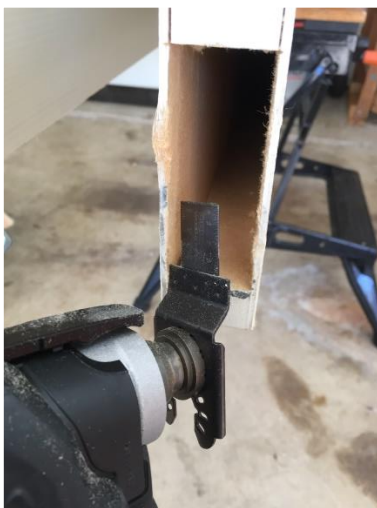
These hollow-core bifold doors use composite MDF strips to separate the textured front and back panels; spacing between them was 30mm. We needed to replace the defective material with wood.

MDF strip displayed the consistency and stiffness of delaminated cardboard.

Marked the cut-line with the "decapitated" base moulding and used a multitool with 3/4" wide blade to remove the defective MDF strip. Slid a thin putty knife between the outside panel and the multitool cutting blade to prevent accidental damage to the panel.
